██████████ Dimensional Report - Executive Summary

Advantagemet has performed a SmartInspect of 1 (one), Explanted ██████████ METAL LINER – 34mm, Part Number: ██████████; in accordance with SAE AS9102 First Article Inspection Requirement. This work was performed under Contract with Purchase Order.

- Dimensional inspection of 1 (one), Explanted ██████████ METAL LINER – 34mm, per Blueprint ██████████

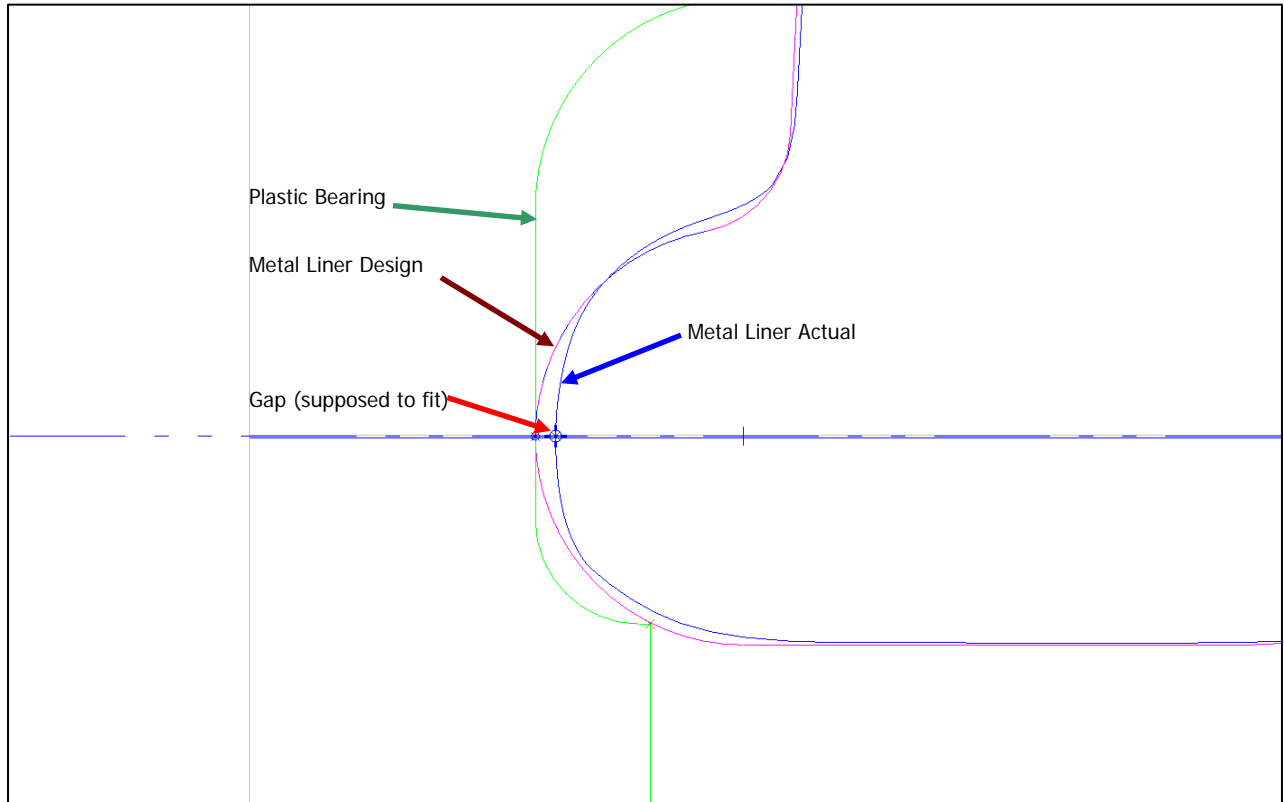
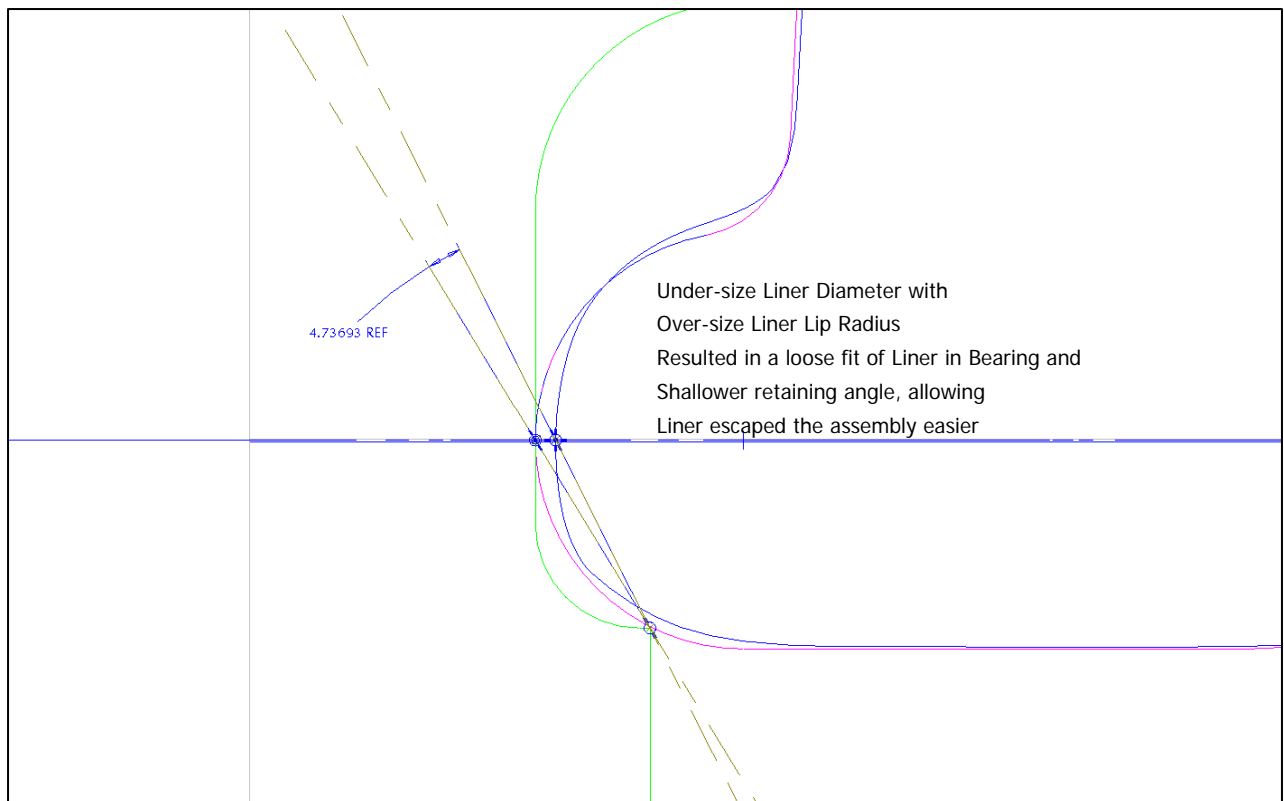
METAL LINER Non-Conformance & Fit Explanation Illustration

- The explanted part shows very little visible wear and several small nicks around the perimeter of D1.
- The measured size of D1 was 1.536002 inches, which is 0.002298 inches under nominal and 0.001298 inches under the tolerance limits set by the blueprint. This dimension is non-conforming and the component should not have been used.
- The undersize condition of D1 coupled with an oversize condition on the poly bearing made an unsound fit.
- Radius D2 was 0.02656 inches, which is 0.00656 inches over nominal and 0.00156 inches over the tolerance limits set by the blueprint. This dimension is non-conforming and the component should not have been used. The size of this radius plays a key role in holding the metal liner in place in the hip implant assembly.

The undersized condition of several of the dimensions relate directly to the fit of the liner in the implant assembly. When considered together, the out of tolerance dimensions would weaken the capture mechanism between the metal inlay and the poly liner. In our professional opinion, these out of tolerance measurements caused or contributed heavily to the metal inlay escaping from the poly liner, which led to the catastrophic failure.

Assembly Interface – Point of Contact
